# Lift Station Evaluation and Capital Improvement Plan

City of Storm Lake  
Storm Lake, IA

January, 2021

Project No. 20-24359

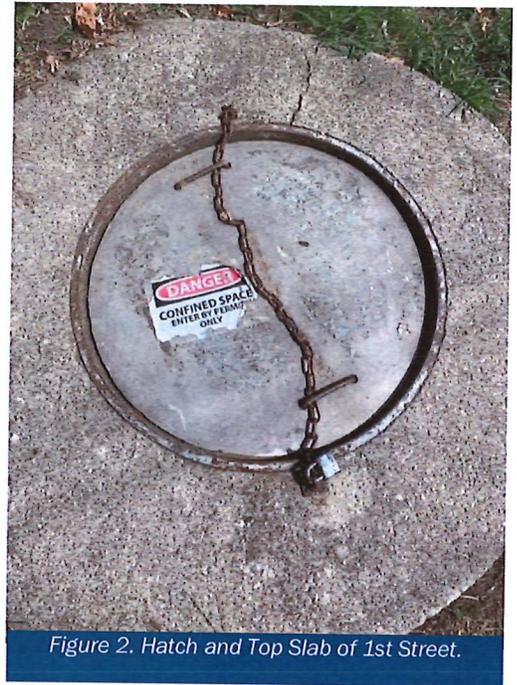
The overall concrete wet well structure appeared in poor condition. The functionality of the wet well is fair, and the top slab and interior walls appeared in poor condition. The hatch to the wet well is aged, in poor condition, and is secured only by a chain and padlock; see Figure 2 for the hatch and top slab condition. The hatch also does not have a safety grate;

Figure 2. Hatch and Top Slab of 1st Street.

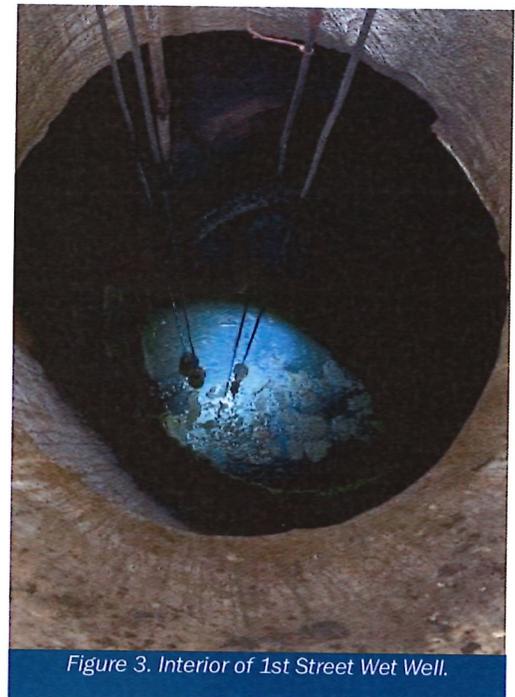
Figure 3. Interior of 1st Street Wet Well.

this is a safety issue as there is no protection for operators as they open the hatch. There is no grinder, screen, or trash basket in place to remove large solids from the wastewater. The interior walls are not epoxy coated, and no solids build-up was observed. There is no ladder leading into the wet well. There is one float level to signal the high-water alarm. See Figure 3 for the interior of the wet well.

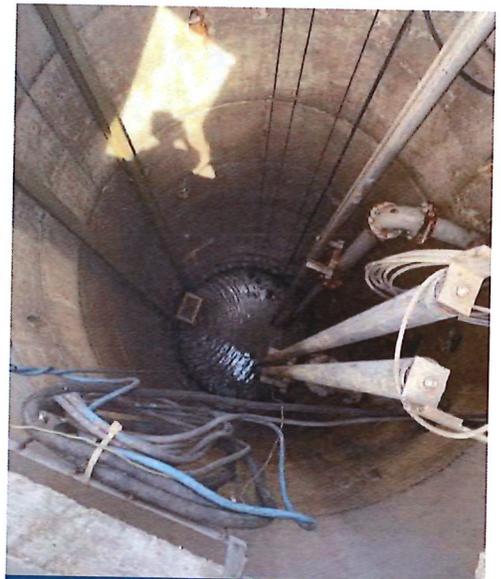
The overall concrete wet well structure appeared in good condition. The functionality of the wet well is good, and the top slab and interior walls appeared in good condition. The hatch to the wet well does not have a safety grate; this is a safety hazard as there is no protection for operators as they open the hatch to the wet well. There is no grinder or screen but there is a trash basket installed so large, solid materials can be removed from the wastewater. The trash basket was in place at the time of the field evaluation. The interior walls are not epoxy coated, and minimal solids build up was observed at the time of the field evaluation. Regular monitoring of potential solids build-up and routine removal of solids from the walls is recommended. The interior walls also exhibited evidence of infiltration through the seams of the precast concrete sections. Minimal corrosion and spalling were observed throughout the structure. See Figure 4 for the interior of the wet well.

Figure 4. Bargloff Wet Well Structure.

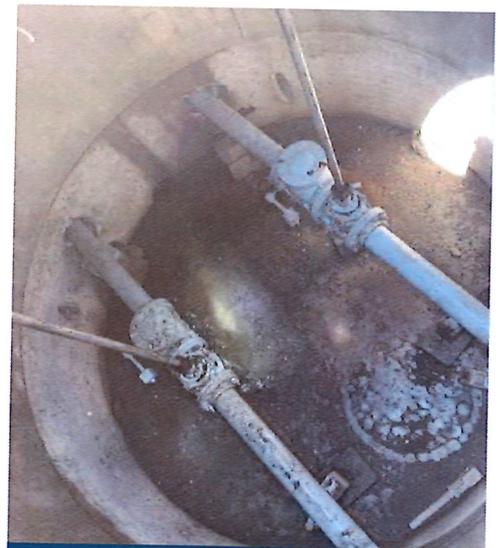
Figure 5. Bargloff Valve Vault.

The overall concrete valve vault structure appeared in good condition. The functionality of the vault is good, and the drainage from the vault to the wet well is good. The bottom slab of the valve vault is angled to allow for gravity drainage to the wet well; however, there is no back-flow preventer on the effluent side of the drainage pipe. Installation of a duck bill back-flow preventer is recommended to prevent flooding of the valve vault in the event the lift station floods with raw wastewater and surpasses the elevation of the valve vault drainpipe. The interior walls and top slab of the vault appeared in good condition with minimal corrosion and spalling. See Figure 5 for the interior of the valve vault.

Priority	Category	Recommendation	Estimated Cost
High	Valve Vault	Install duck bill back-flow preventer on valve vault gravity drain	Cost included in Additional Maintenance items
Medium	Electrical	Install site light for security and service	\$1,800

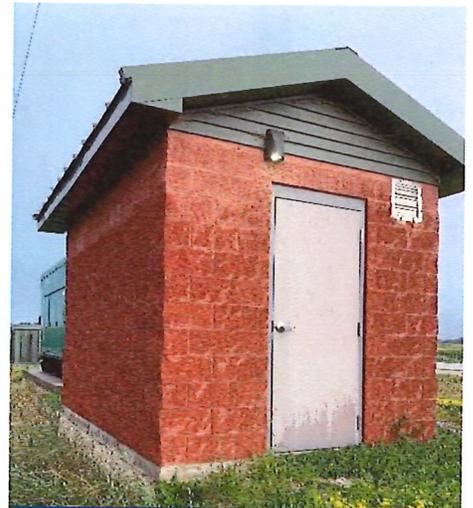
Figure 6. C-65 Building Structure.

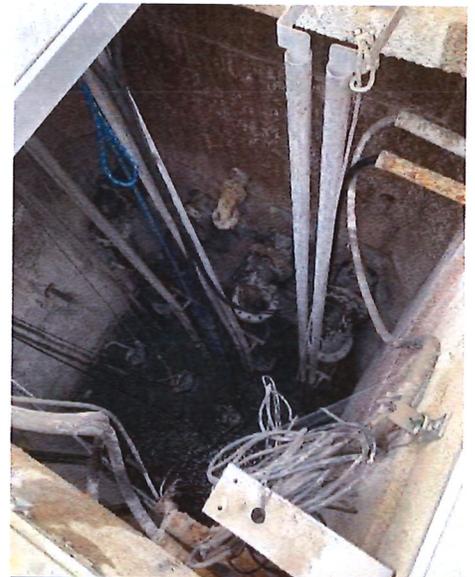
The overall concrete wet well structure appeared in fair condition. The functionality of the wet well is good, and the top slab and interior walls appeared in good condition. The hatches to the wet well do not have safety grates; this is a safety issue as there is no protection for operators as they open the hatches to the wet well. There is no grinder or screen, but there is a trash basket installed so large, solid materials can be removed from the wastewater. The trash basket was not in place at the time of the field evaluation. The interior

Figure 7. C-65 Wet Well.

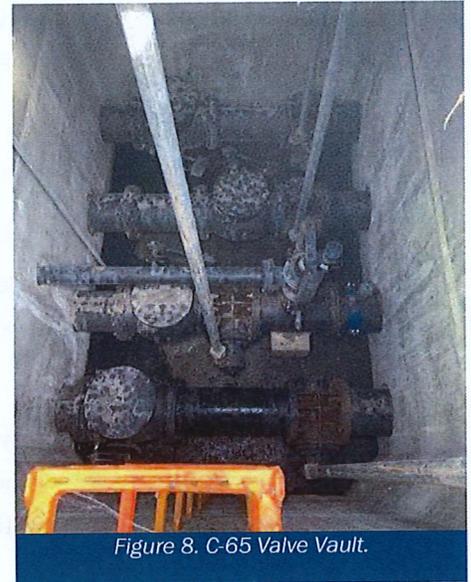
Figure 8. C-65 Valve Vault.

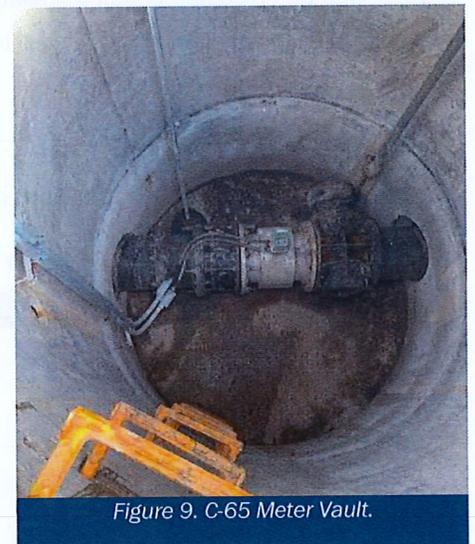
Figure 9. C-65 Meter Vault.

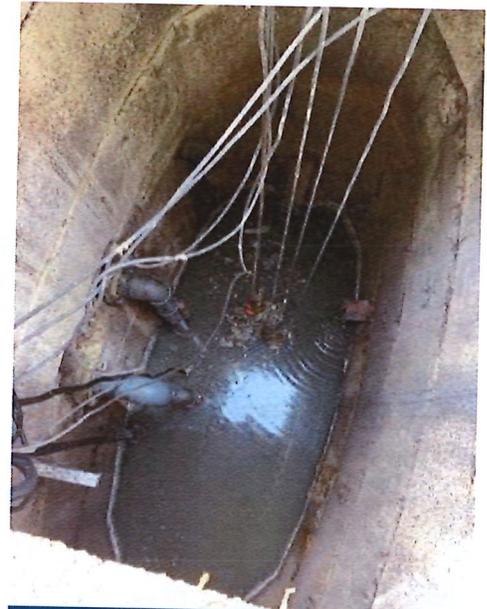
Figure 10. Campground Wet Well.

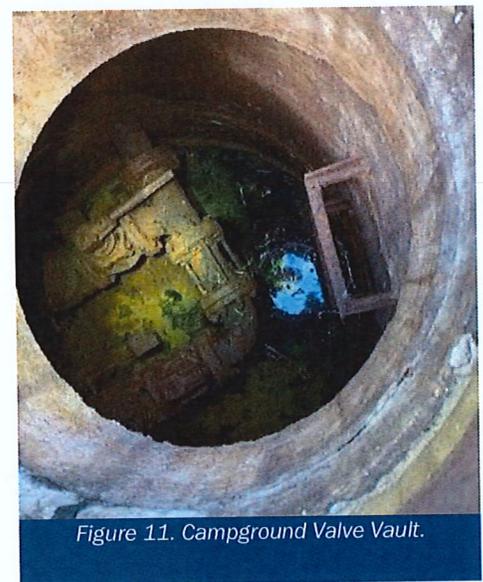
Figure 11. Campground Valve Vault.

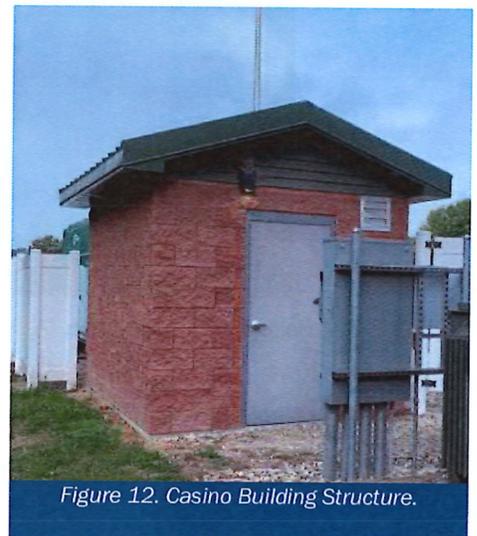
The overall building structure appeared in good condition. There were no structure quality issues or modifications needed. See Figure 12 for the building structure.

Figure 12. Casino Building Structure.

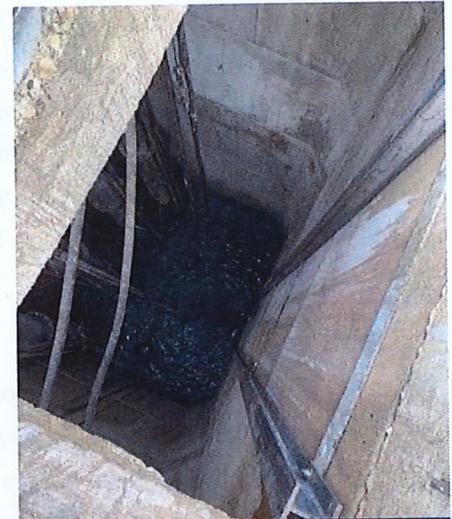
The overall concrete wet well structure appeared in good condition. The functionality of the wet well is good, and the top slab and interior walls appeared in good condition. The hatches to the wet well do not have safety grates; this is a safety hazard as there is no protection for operators as they open the hatches to the wet well. There is no grinder or screen, but there is a trash basket installed so large, solid materials can be removed from the wastewater. The trash basket was not in place at the time of the field evaluation. The interior walls are not epoxy coated, and minor solids build up was observed at the time of the field evaluation. The walls and the top slab of the wet well showed minimal corrosion and spalling. There was notable I&I around one of the wet well effluent pipes; city personnel noted a nearby water main break. Performing a leak detection analysis on the water main servicing the nearby area to determine the source of the leak, and repairing the leak, is recommended to limit I&I in the lift station. See Figure 13 for the interior of the wet well.

Figure 13. Casino Wet Well.

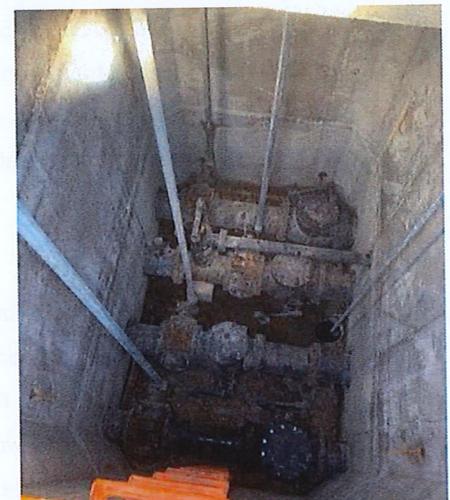
The overall concrete valve vault structure appeared in fair condition. The functionality of the vault is good, and the drainage from the vault to the wet well is good. The bottom slab of the valve vault is angled to allow for gravity drainage to the wet well, and there is a back-flow preventer on the effluent side of the drainage pipe; the back-flow preventer was noted as a duck bill non-return valve. Water was noted on the bottom of the vault at the time of the field evaluation, though it was draining to the wet well. The excess water most likely came from I&I due to the nearby water main break. The interior walls and top slab of the vault appeared in good condition with minimal corrosion and spalling. See Figure 14 for the interior of the valve vault.

Figure 14. Casino Valve Vault.

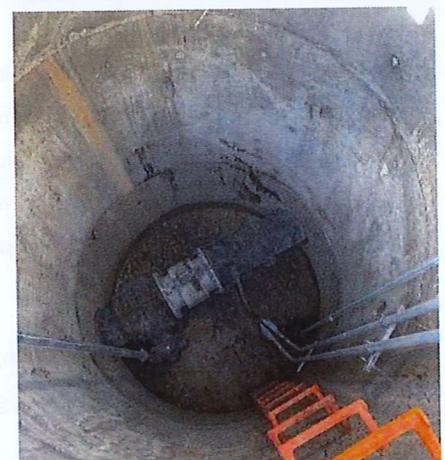
The overall concrete meter vault structure appeared in good condition. The functionality of the vault is fair, and the drainage is fair. There is a gravity drain from the vault to the wet well, however, the vault has flooded with wastewater in the past. The electromagnetic meter is no longer operational because of the flooding. In the past, the meter was submerged in water causing the transmitter to short out. Removing the transmitter from the meter vault and installing a remote transmitter in the control building is recommended. The interior walls and top slab of the vault appeared in good condition with minimal corrosion and spalling. See Figure 15 for the interior of the meter vault.

Figure 15. Casino Meter Vault.

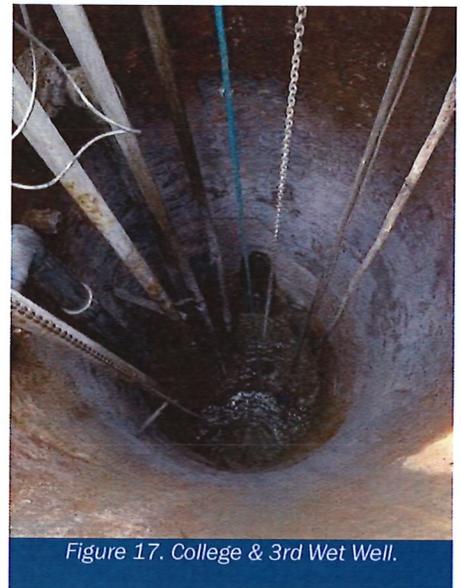
The overall concrete wet well structure appeared in poor condition. The functionality of the wet well was fair, but the top slab and interior walls of the wet well appeared aged and in poor condition. The hatch to the wet well is in poor condition and does not have a safety grate; this is a safety hazard as there is no protection for operators as they open the hatch. There is no grinder, screen, or trash basket installed in the wet well, and minimal solids build-up was observed at the time of the field evaluation. The influent pipes appeared aged and severely corroded. The interior walls of the wet well have a fiberglass lining that is deteriorating, and the top slab is cracked and spalling. Replacing the top slab and hatch to the wet well is not recommended until significant rehabilitation is done to the lift station. See Figure 17 for the interior of the wet well.

Figure 17. College & 3rd Wet Well.

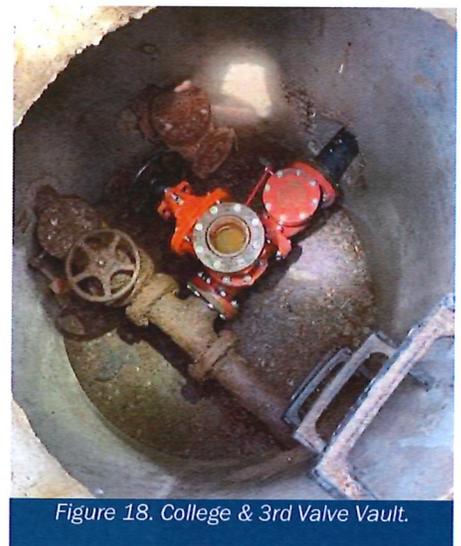
Figure 18. College & 3rd Valve Vault.

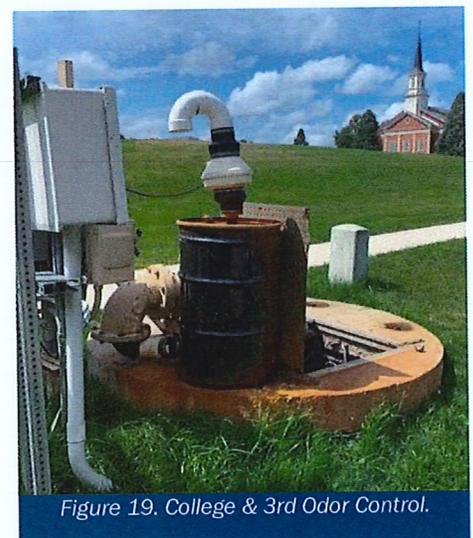
Figure 19. College & 3rd Odor Control.

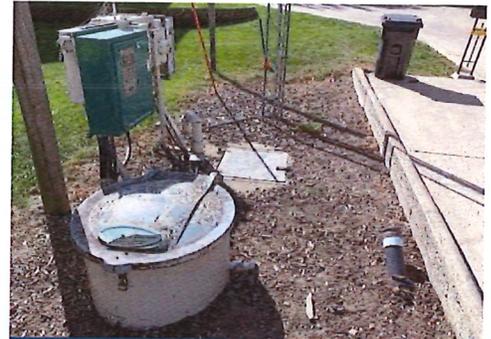
Figure 20. Emerald Park Site Layout.

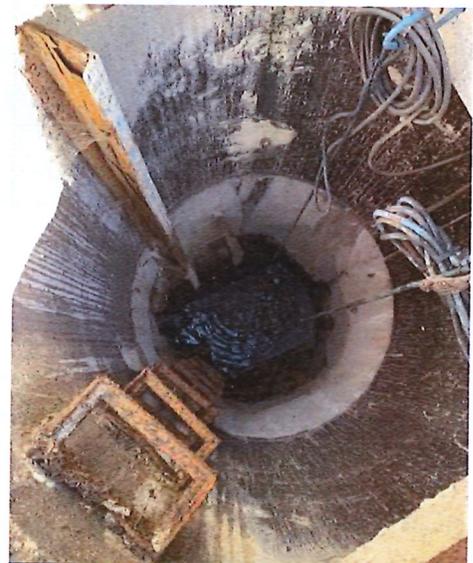
The overall concrete wet well structure appeared in poor condition. The functionality is fair, but the top slab and interior walls are in poor condition with corrosion, cracking, and spalling. The interior walls are not epoxy coated, but minimal solids build-up was observed at the time of the field evaluation. The hatch to the wet well is in poor condition and does not have a safety grate; this is a safety hazard as there is no protection for operators as they open the hatch. There is no grinder, screen, or trash basket installed in the wet well. See Figure 21 for the interior of the wet well.

Figure 21. Emerald Park Wet Well.

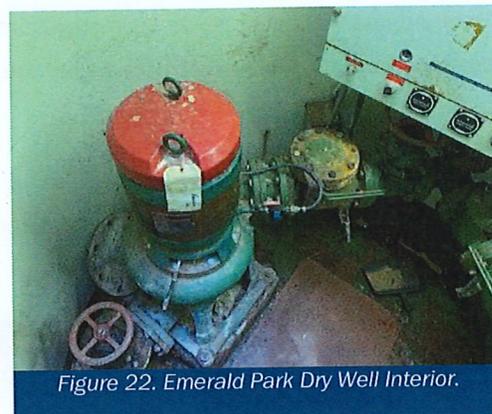
Figure 22. Emerald Park Dry Well Interior.

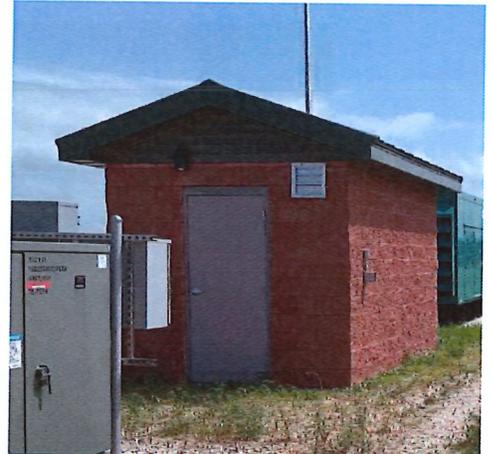
Figure 23. Field of Dreams Building Structure.

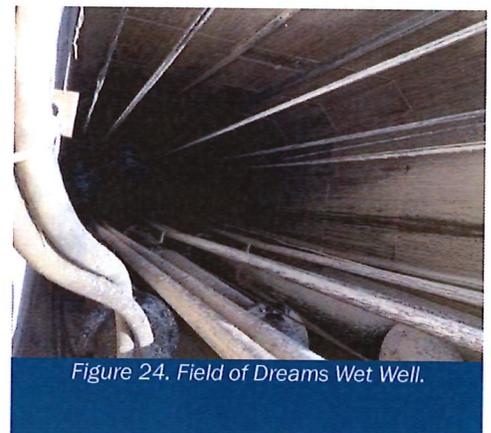
The overall concrete wet well structure appeared in good condition. The functionality of the wet well is good, and the top slab and interior walls appeared in good condition. The hatches to the wet well do not have safety grates; this is a safety hazard as there is no protection for operators as they open the hatches to the wet well. There is no grinder or screen, but there is a trash basket installed so large, solid materials can be removed from the wastewater. The trash basket was not in place at the time of the field evaluation. The interior walls are not epoxy coated and there is a thin layer of lime build-up on the walls and pipes. Lime softening waste generated by the

Figure 24. Field of Dreams Wet Well.

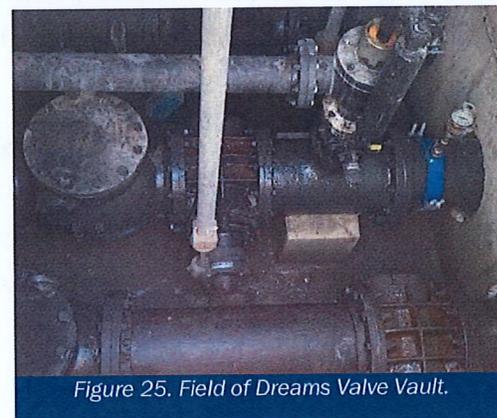
The overall concrete valve vault structure appeared in good condition. The functionality of the vault is good, and the drainage from the vault is good. The bottom slab of the vault is angled to allow for gravity drainage to the wet well, however, there is no back-flow preventer on the effluent side of the drainage pipe. Installation of a duck bill back-flow preventer is recommended to prevent flooding of the valve vault in the event the lift station floods with raw wastewater and surpasses the elevation of the valve vault drainpipe. The hatch to the valve vault does not have a lock to protect from unauthorized access; installation of a locking hasp and padlock is recommended. The interior walls and top slab of the vault appeared in good condition with minimal corrosion and spalling. See Figure 25 for the interior of the valve vault.

Figure 25. Field of Dreams Valve Vault.

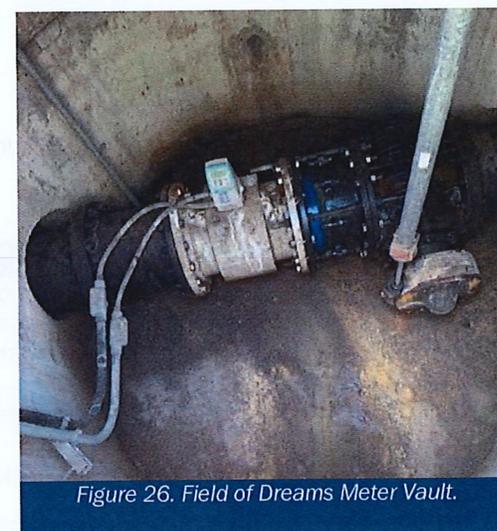
The overall concrete meter vault structure appeared in good condition. The functionality of the vault is good, and the drainage is fair. The vault has a history of flooding with snow melt because of site contours. The electromagnetic meter does not work because of the flooding. The meter has been submerged in the past causing the transmitter to short out. Removing the transmitter from the meter vault and installing a remote transmitter in the control building is recommended. The hatch to the meter vault does not have a lock to protect from unauthorized access; installation of a locking hasp and padlock is recommended. The interior walls and top slab of the vault appeared in good condition with minimal corrosion and spalling. See Figure 26 for the interior of the meter vault.

Figure 26. Field of Dreams Meter Vault.

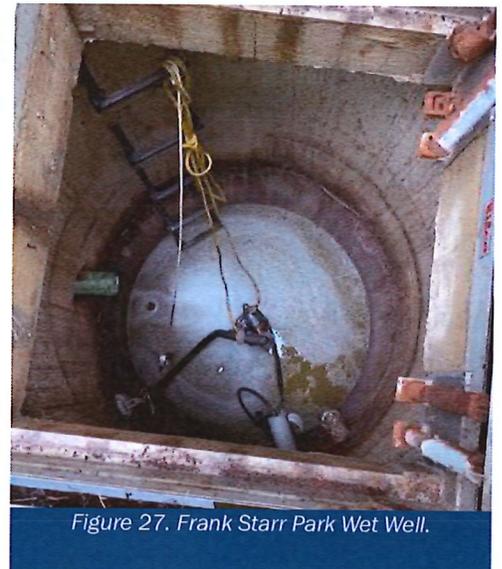
The overall concrete wet well structure appeared in fair condition. The functionality of the wet well is good, and the top slab and interior walls appeared in good condition. The hatch to the wet well is in poor condition and does not have a safety grate; this is a safety issue as there is no protection for operators as they open the hatch to the wet well. The hatch is also always unlocked and unprotected from unauthorized access. There is no screen or trash basket, but there is a grinder pump installed in the wet well. The interior

Figure 27. Frank Starr Park Wet Well.

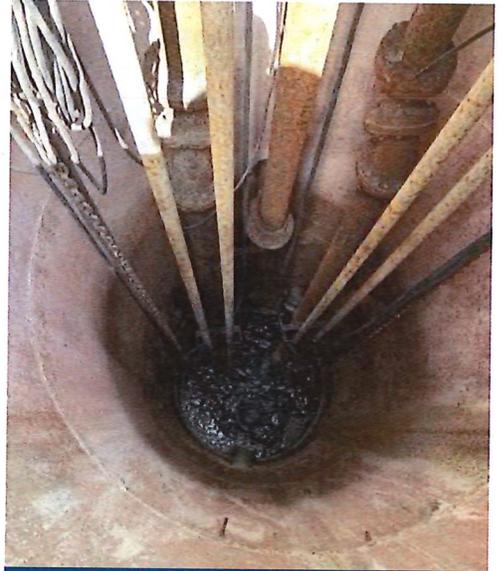
Figure 28. Golf Course Wet Well.

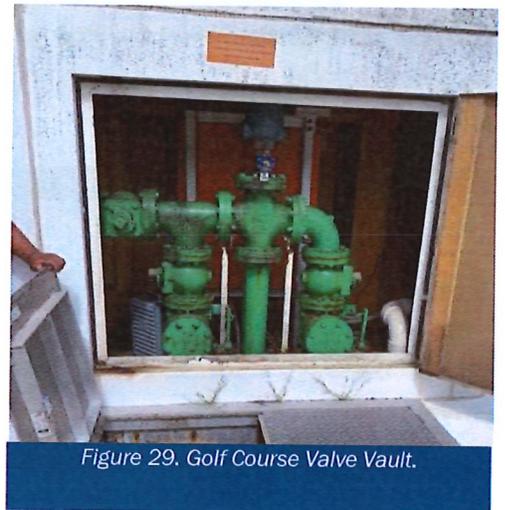
Figure 29. Golf Course Valve Vault.

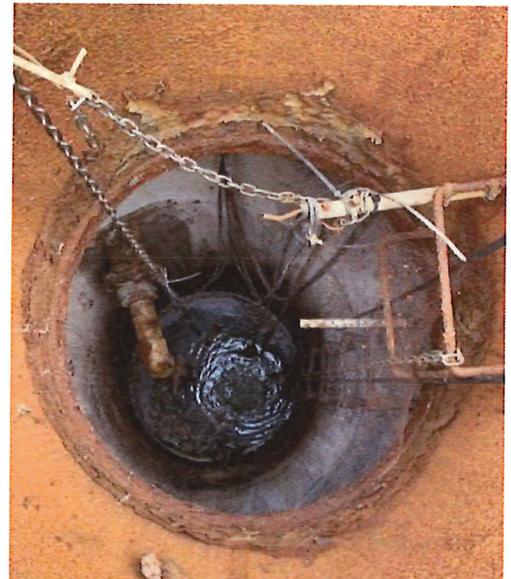
The overall concrete wet well structure appeared in fair condition. The functionality of the wet well is poor, the steel manway appeared in poor condition, and the concrete interior walls appeared in good condition. There is no safety grate at the entrance to the steel manway, which is a safety hazard to operators opening the manway. The steel manway is severely rusted and aged; see Figure 30 for the steel manway and interior of the wet well. There is

Figure 30. Ice House Wet Well.

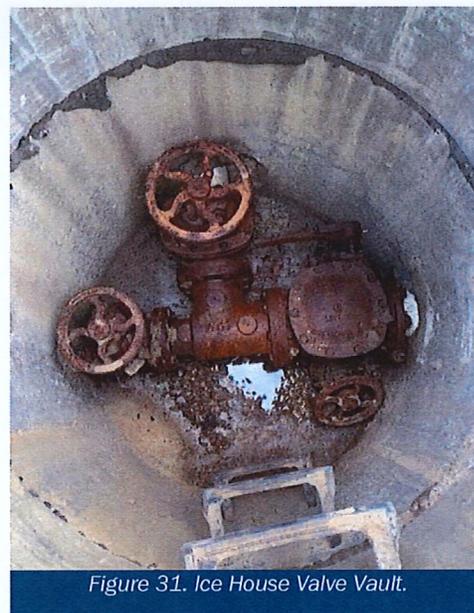
Figure 31. Ice House Valve Vault.

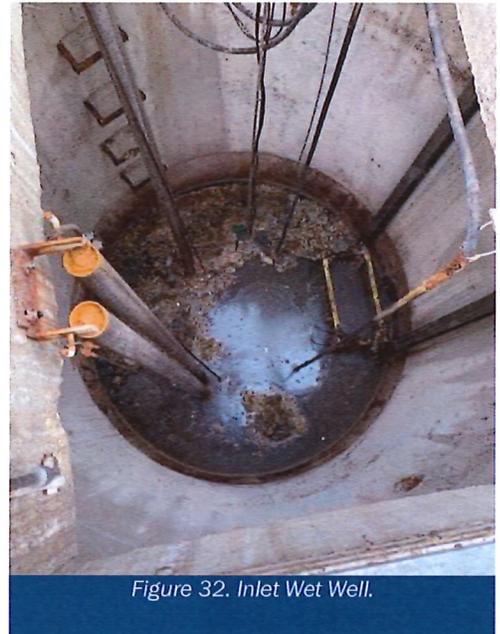
The overall concrete wet well structure appeared in poor condition. The functionality of the wet well was poor, the interior walls were in fair condition, and the top slab was in good condition. The hatches to the wet well do not have safety grates; this is a safety issue as there is no protection for operators as they open the hatches to the wet well. There is no grinder or screen, but there is a trash basket installed so large, solid materials can be removed from the wastewater; the trash basket was in place at the time of the field evaluation. The interior walls are not epoxy coated and have minor solids build-up. Minimal corrosion and spalling were observed on the structure at the time of the field evaluation. See Figure 32 for the interior of the wet well.

Figure 32. Inlet Wet Well.

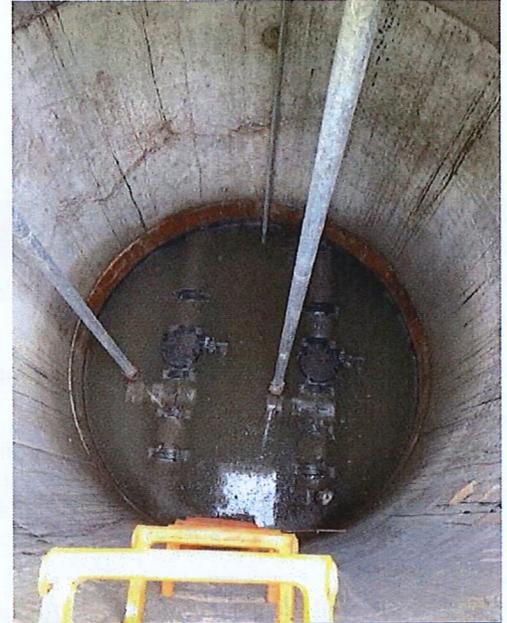
Figure 33. Inlet Valve Vault.

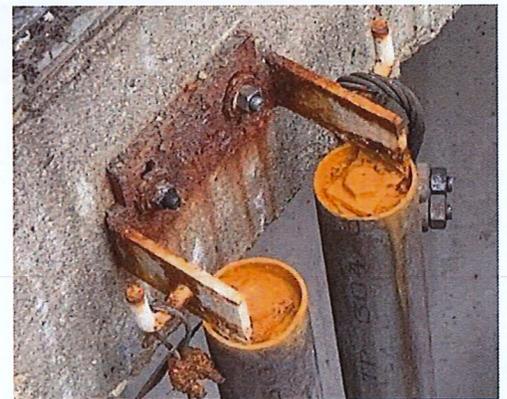
Figure 34. Rusted Pump Guide Rail Brackets.

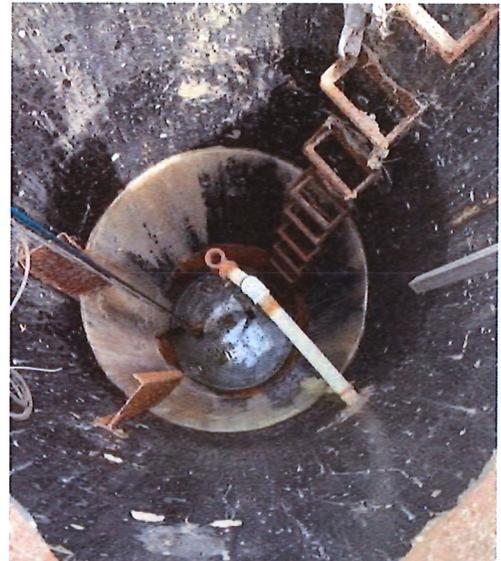
The overall concrete wet well structure appeared in poor condition. The functionality, top slab, and interior walls also are in poor condition. The top slab is cracked, and the lining on the interior walls is deteriorating. The hatch to the wet well does not have a safety grate; this is a safety hazard as there is no protection for operators as they open the hatch. The hatch and vent from the wet well may have been hit by a vehicle and appeared damaged.

Figure 35. IPS Wet Well.

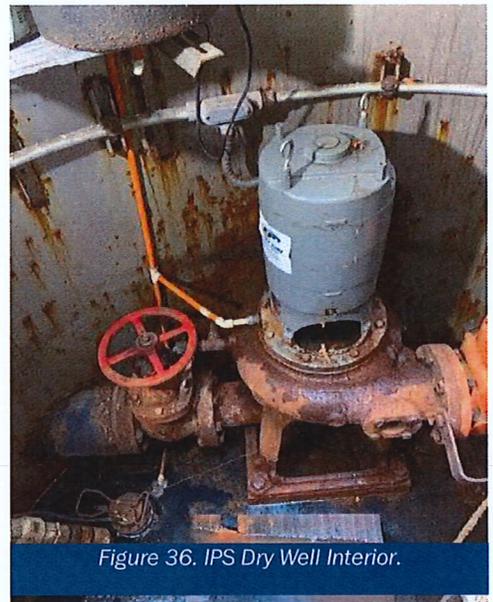
Figure 36. IPS Dry Well Interior.

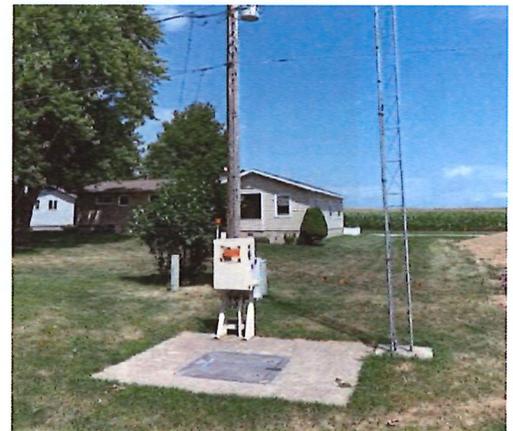
Figure 37. Northwestern Site.

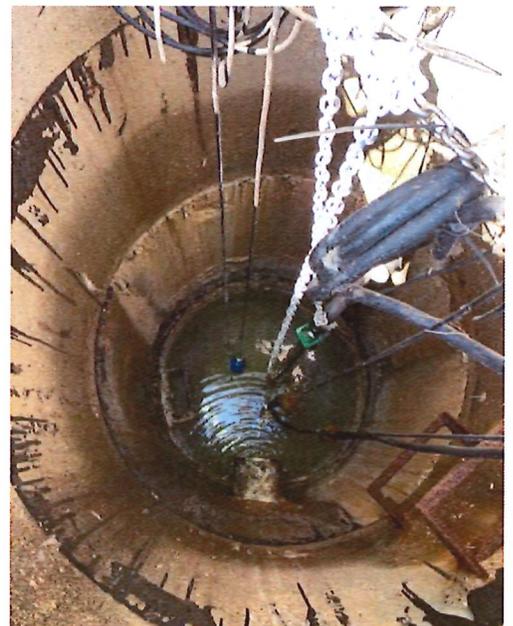
The overall concrete wet well structure appeared in poor condition. The general functionality of the wet well is poor, and the top slab and interior walls appeared in poor condition. The hatch to the wet well does not have a safety grate and is a safety hazard to operators as they are not protected when they open the hatch. The top slab is cracked and flush with the ground, the hatch is offset from its original placement, and water infiltrates the cast-in-place wet well through the seams of the interior walls. Removing the existing top slab and replacing it with a new, raised slab is recommended; a new, accessible latch

Figure 38. Northwestern Wet Well.

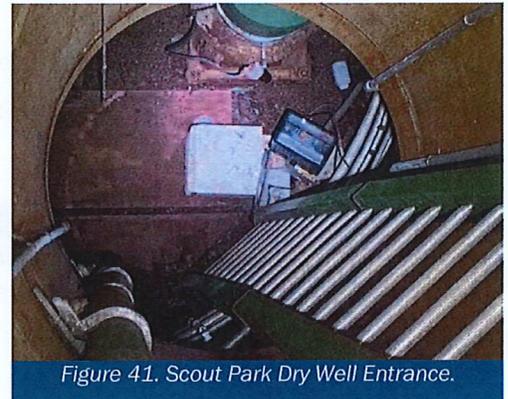
Figure 41. Scout Park Dry Well Entrance.

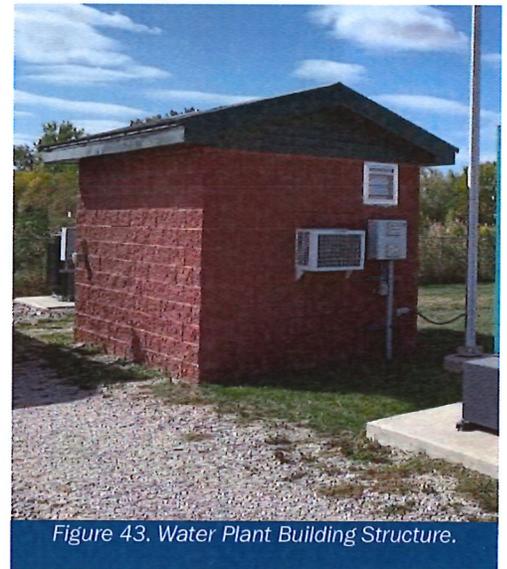
Figure 43. Water Plant Building Structure.

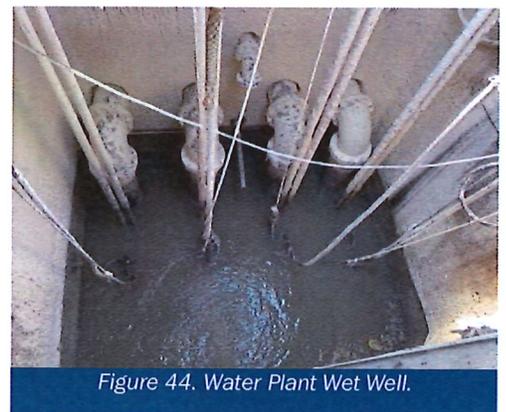
The overall concrete wet well structure appeared in good condition. The functionality of the wet well is good, and the top slab and interior walls appeared in good condition. The hatches to the wet well do not have safety grates; this is a safety issue as there is no protection for operators as they open the hatches to the wet well. There is no grinder or screen, but there is a trash basket installed so large, solid materials can be removed from the wastewater. The trash basket was not in place at the time of the field evaluation. The interior walls are not epoxy coated and there is a thick layer of lime build-up on the walls and pipes. Lime softening waste generated by the water plant is poured directly into the Water Plant lift station primarily to provide alkalinity to the wastewater treatment plant. The lime also raises the pH of the wastewater and

Figure 44. Water Plant Wet Well.

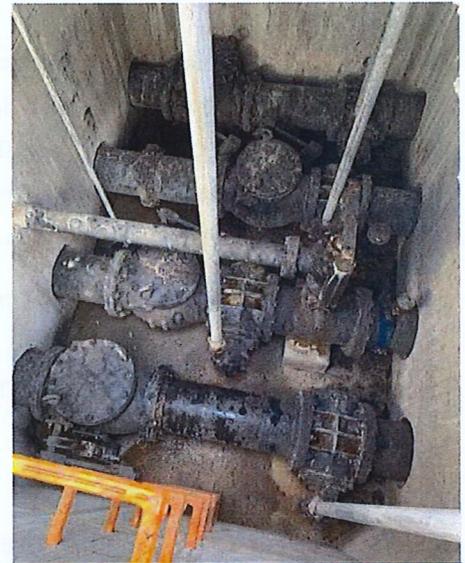
The overall concrete valve vault structure appeared in good condition. The functionality of the vault is good, and the drainage from the vault is good. The bottom slab of the vault is angled to allow for gravity drainage to the wet well; however, there is no back-flow preventer on the effluent side of the drainage pipe. Installation of a duck bill back-flow preventer is recommended to prevent flooding of the valve vault in the event the lift station floods with raw wastewater and surpasses the elevation of the valve vault drainpipe. The interior walls and top slab of the vault appeared in good condition with minimal corrosion and spalling. See Figure 45 for the interior of the valve vault.

Figure 45. Water Plant Valve Vault.

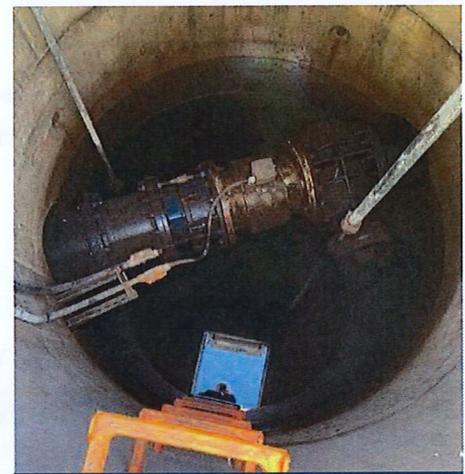
The overall concrete meter vault structure appeared in good condition. The functionality of the vault is fair, and the drainage is poor. There is a gravity drain from the vault to the wet well; however, the vault has flooded with storm water in the past and the vault was flooded with storm water at the time of the field evaluation. City staff confirmed this was because the gravity drain is blocked. Cleaning the gravity drain to repair the drainage in the vault is recommended. The electromagnetic flow meter is functional, but the remote mounted flow transmitter is not. Repairing or replacing the flow transmitter is recommended; refer to the control and instrumentation category. The interior walls and top slab of the vault appeared in good condition with minimal corrosion and spalling. See Figure 46 for the interior of the meter vault.

Figure 46. Water Plant Meter Vault.

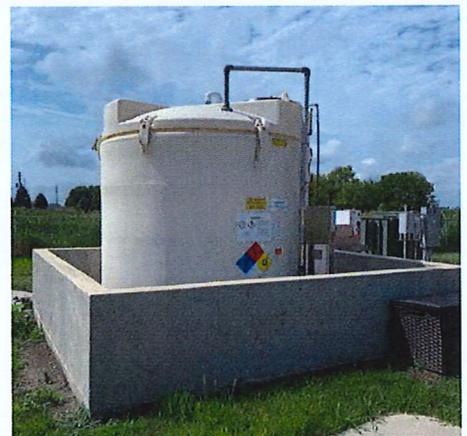
Figure 47. Water Plant Odor Control System.
