# Lift Station Evaluation and Capital Improvement Plan

City of Storm Lake  
Storm Lake, IA

January, 2021

Project No. 20-24359

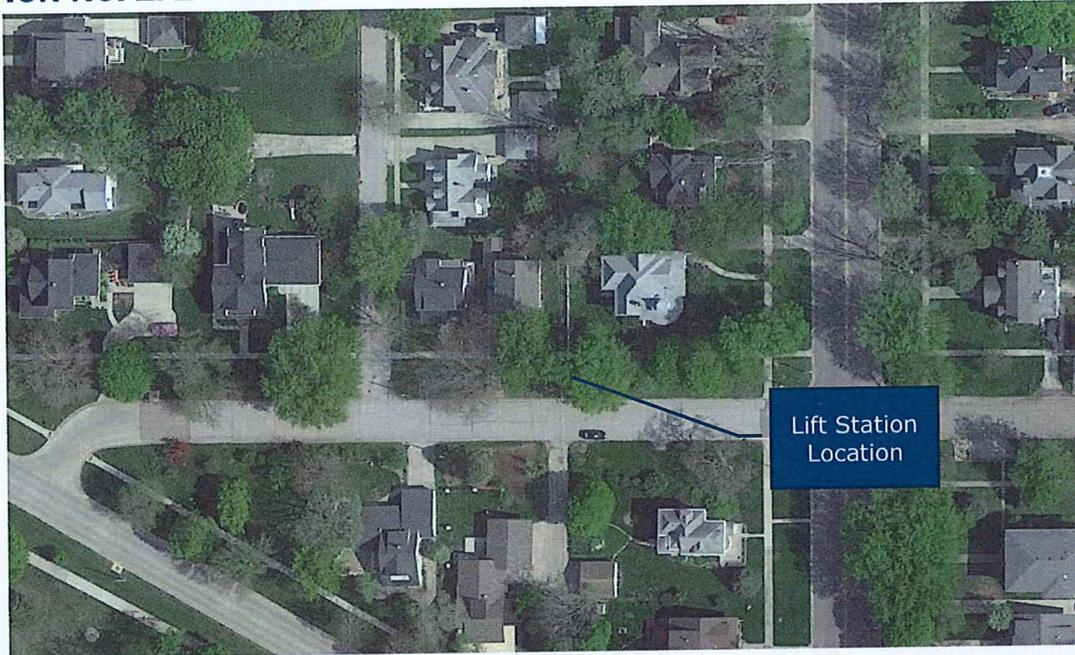
**LIFT STATION NO. 1: 1<sup>ST</sup> STREET**

The site is not located in the 100-year floodplain. The overall site of the lift station appeared in fair condition; the lift station is located near a curb and between two homes along West 1<sup>st</sup> Street. Service vehicles have adequate space to access the lift station for maintenance via the paved road on site. The wet well hatch and electrical panel are surrounded by grass on a slope graded away from the homes, leading to sufficient drainage and a lack of hard surfaces surrounding the station. The lift station site does have an alarm signaling system in place to notify operators of any malfunctions or emergencies. The site does not have a fence and gate to protect from unauthorized personnel, and the wet well hatch is not securely protected from illegal access.

The overall concrete wet well structure appeared in poor condition. The functionality of the wet well is fair, and the top slab and interior walls appeared in poor condition. The hatch to the wet well is aged, in poor condition, and is secured only by a chain and padlock; see Figure 2 for the hatch and top slab condition. The hatch also does not have a safety grate;

The lift station has aging equipment. All metallic enclosures have peeling paint or visible corrosion. Conduit seal-offs are not installed in the conduits from the wet well to the control panel to provide an explosion barrier.

Priority	Category	Recommendation	Estimated Cost
High	Lift Station Overview	Full replacement by FY 2024	\$348,000

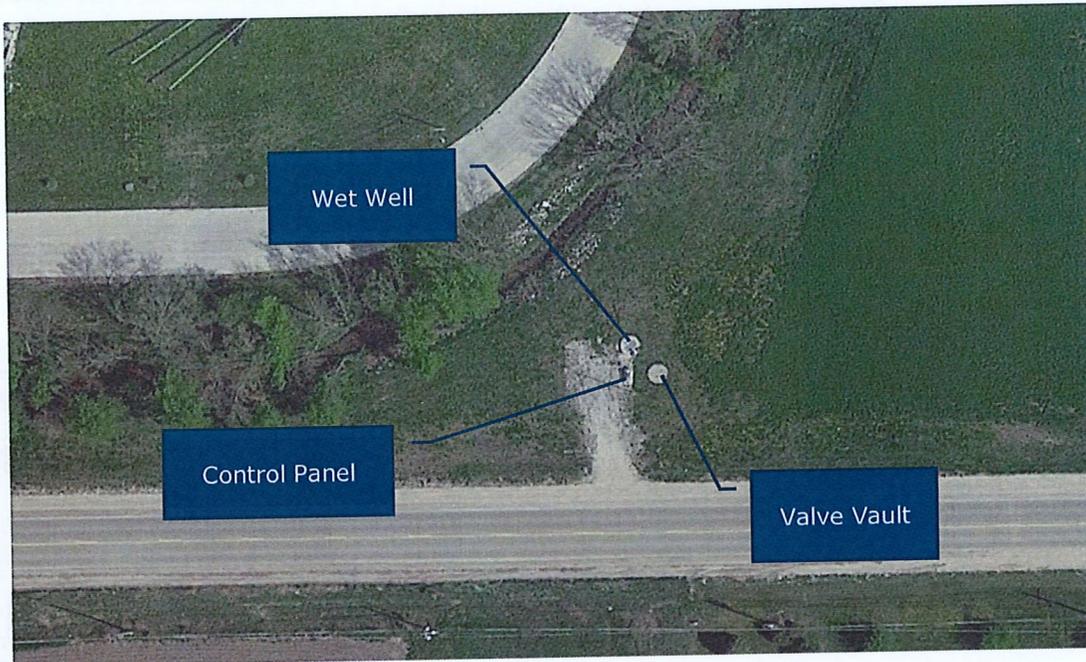
**LIFT STATION NO. 2: BARGLOFF**

The site is not located in the 100-year floodplain. The overall site of the lift station appeared in good condition. Service vehicles have ample space to access the lift station for maintenance, but there is no paved or gravel access road on site; vehicles must drive on a grass surface. City personnel confirmed the site has sufficient drainage, and the hatches of the wet well and valve vault have not knowingly been submerged. The lift station site does have an alarm system in place to notify operators of any malfunctions or emergencies. The site does not have a fence and gate to protect from unauthorized access, but the wet well, valve vault, and control panel are always locked.

Priority	Category	Recommendation	Estimated Cost
High	Valve Vault	Install duck bill back-flow preventer on valve vault gravity drain	Cost included in Additional Maintenance items
Medium	Electrical	Install site light for security and service	\$1,800

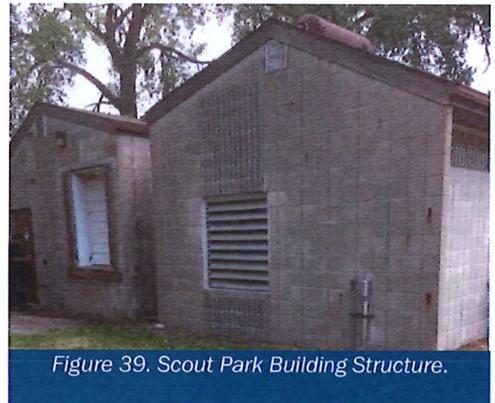
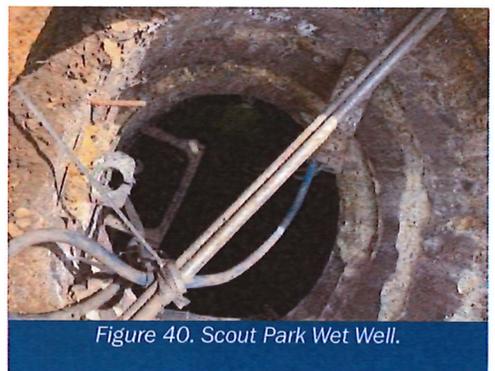
The overall concrete wet well structure appeared in poor condition. The barrel of the structure is severely spalled, and the interior walls of the structure are deteriorating. The inlet pipe to the wet well allows wastewater to plunge more than two feet to the wet well. There is no grinder, screen, or trash basket installed in the wet well. See Figure 40 for the interior of the wet well.

The overall coated steel dry well structure appeared in poor condition. The steel manway at the entrance to the dry well appeared in good condition as it is protected by the building structure. The remainder of the structure, however, appeared aged and rusted. Operators also must wear hearing protection in order to enter the structure because of equipment noise. The equipment in the dry well is accessible but failing. See Figure 41 for the entrance to the dry well.

Priority	Category	Recommendation	Estimated Cost
High	N/A	Full replacement	\$1,200,000
High	N/A	New pumps and valves (interim rehabilitation)	\$11,600
